Manhole Inspection Summary

Manhole # S67M__015MH

Inspection ☐ Is Incomplete Rating: **3) Fair**

Location Address: **Elliott St.**

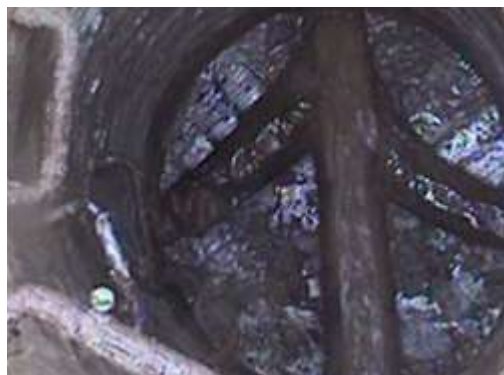
Top View

Infiltration: ☐ None ☐ Joint ☐ Cracks ☒ Mortar ☐ Roots ☐ Wall

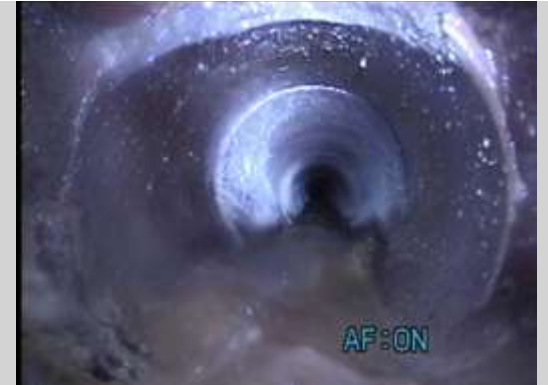
12 O'Clock Outflow

10 in. Circular Gravity Sewer
Pipe Out @ 12 O'Clock

Pipe Height: **9.6** (in.) Rod and Bar (Angled)
Pipe Material: **Clay** ☐ Pipe Lined
Invert Depth: **9.50** (ft.) Flow Characteristics: **Fast**
Deposits: ☒ None ☐ Mud ☐ Sludge ☐ Debris ☐ Grease
Silt Depth: (in.) Deposits Extent:
Infiltration: **None** Pipe Seal Cond: **Sound**

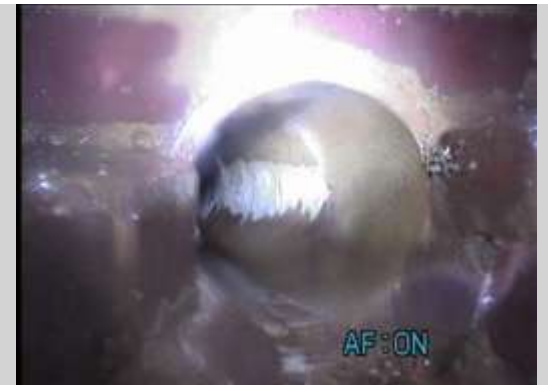
3 O'Clock Inflow

6 in. Circular Gravity Sewer
Pipe In @ 3 O'Clock

Pipe Height: **6** (in.) Rod and Bar (Angled)
Pipe Material: **Clay** ☐ Pipe Lined
Invert Depth: **9.08** (ft.) Flow Characteristics: **Slow**
Deposits: ☒ None ☐ Mud ☐ Sludge ☐ Debris ☐ Grease
Silt Depth: (in.) Deposits Extent:
Infiltration: **None** Pipe Seal Cond: **Sound**

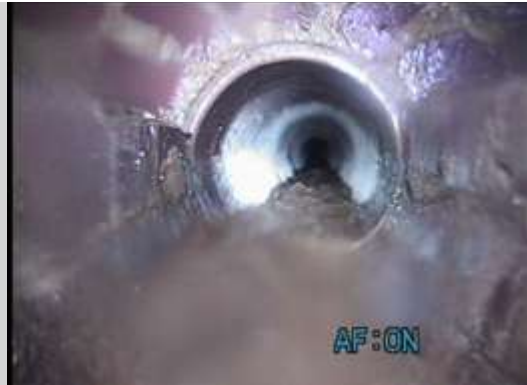
6 O'Clock Inflow

10 in. Circular Gravity Sewer

Pipe In @ 6 O'Clock

Pipe Height: **9.6** (in.) Rod and Bar (Angled)

Deposits: ☒ None ☐ Mud ☐ ~~Sludge~~ ☐ **Debris** ☐ Grease

Infiltration: **None** Pipe Seal Cond: **Sound**

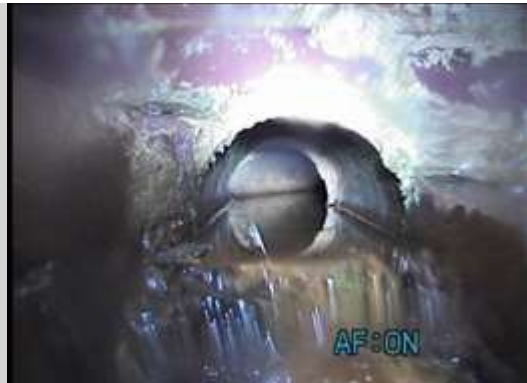
9 O'Clock Inflow

6 in. Circular Gravity Sewer

Pipe In @ 9 O'Clock

Deposits: ☐ None ☐ Mud ☒ ~~Sludge~~ ☒ **Debris** ☐ Grease

Silt Depth: **2** (in.) Deposits Extent: **Heavy**
